Chadbourne Dam Repair and Fish Barrier

Final Report for the Western Native Trout Initiative

Project Title: Chadbourne Dam Repair and Retrofit

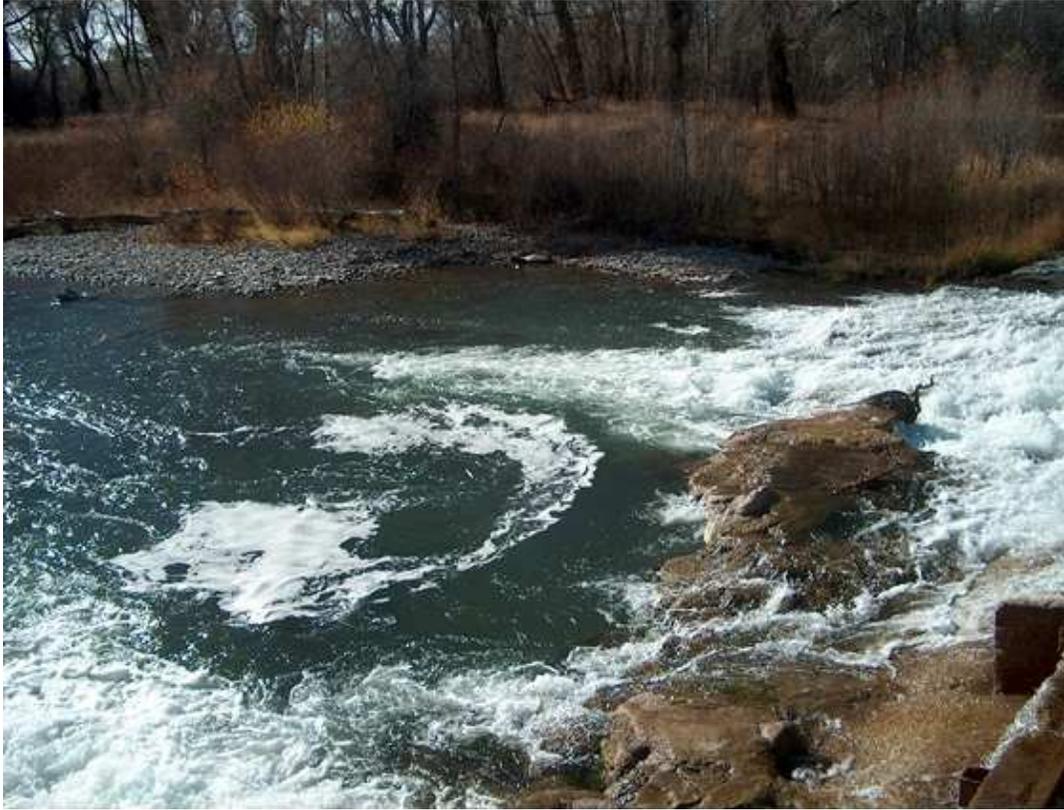
This project has been a conservation priority for Yellowstone cutthroat trout since 2004, with recognition of the potential for rainbow trout to pass over the Chadbourne diversion, and awareness of the structure's state of disrepair and potential for failure. Annual fish surveys have found large, apparent fluvial rainbow trout upstream of the diversion, and these fish likely originate in the lower Shields or Yellowstone rivers (S.T. Opitz, FWP, personal communication). Observable spalling and erosion of concrete, and the presence of a large scour hole downstream (Figure 2), resulted in concern regarding the structural stability of the diversion.

Figure 2. Scour hole and concrete poured to prevent the scour hole from undermining the structure.

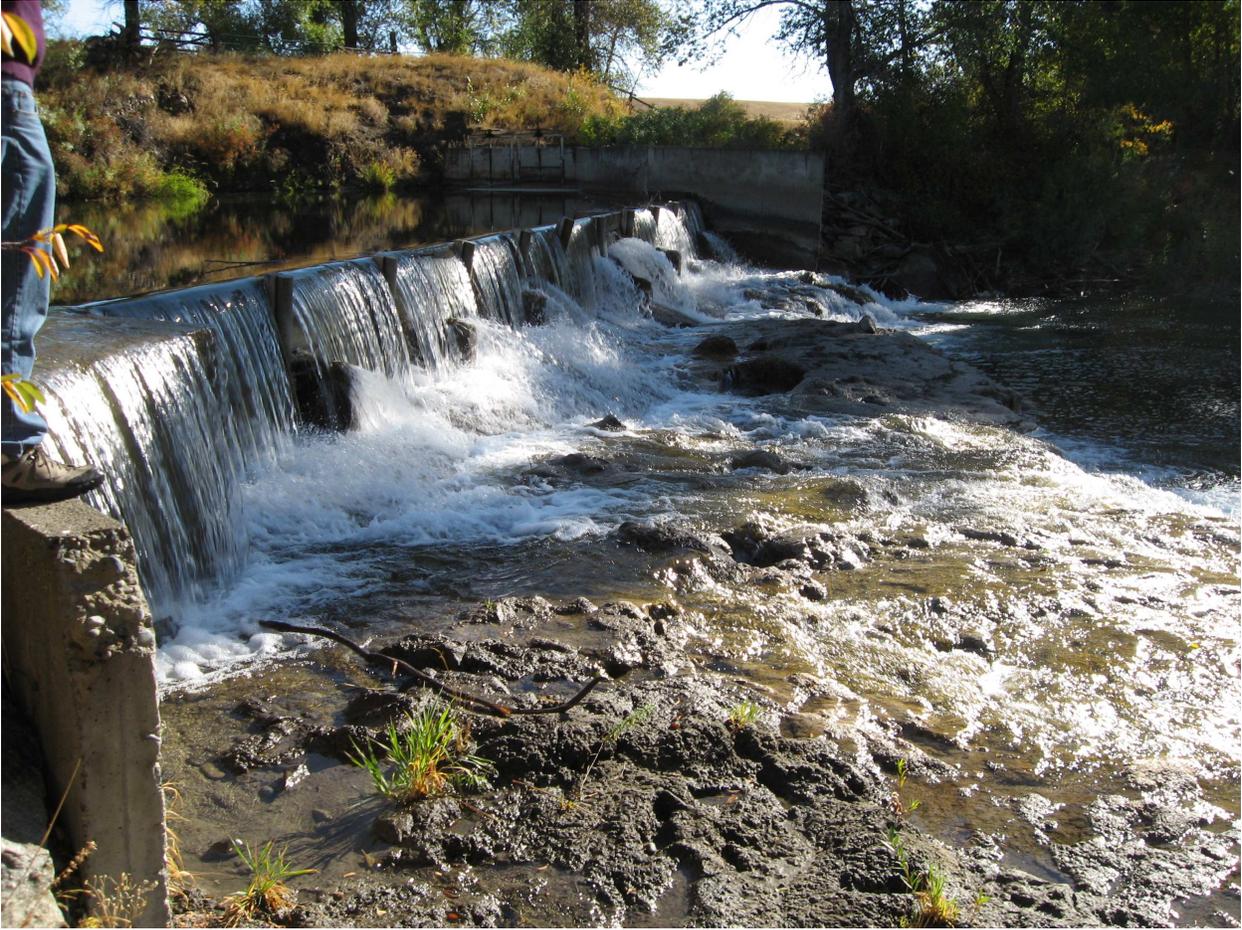
To answer concerns regarding structural stability and the potential for fish passage, FWP commissioned 4 studies addressing these issues (Confluence 2006; OASIS 2006; Fullerton 2010; Allied Engineering 2011). Several features were likely to allow fluvial rainbow trout to pass over the diversion. The scour hole presented a vantage for fish to use upwelling to leap towards the face of the diversion. Moreover, maintenance to protect the scour hole from undermining the structure entailed occasional concrete pours to fill the hole. This accumulation of an irregular concrete slab resulted in a decrease in the height of the diversion, and provided roughness up to the face of the dam (Figure 3). These alterations potentially provided conditions conducive to allowing fish to leap over the dam during high flows. In addition, hydraulic modeling suggested fish may be capable of passing through a notch designed to pass bed load and large wood (Figure 4). During irrigation season, the canal company installed check boards in this notch to ensure flow into the canal. For the rest of the year, the notch was open, and rainbow trout were likely to pass the notch during certain flows (OASIS 2006).

Figure 3. Irregular concrete slab that decreased the leap height, and provided roughness

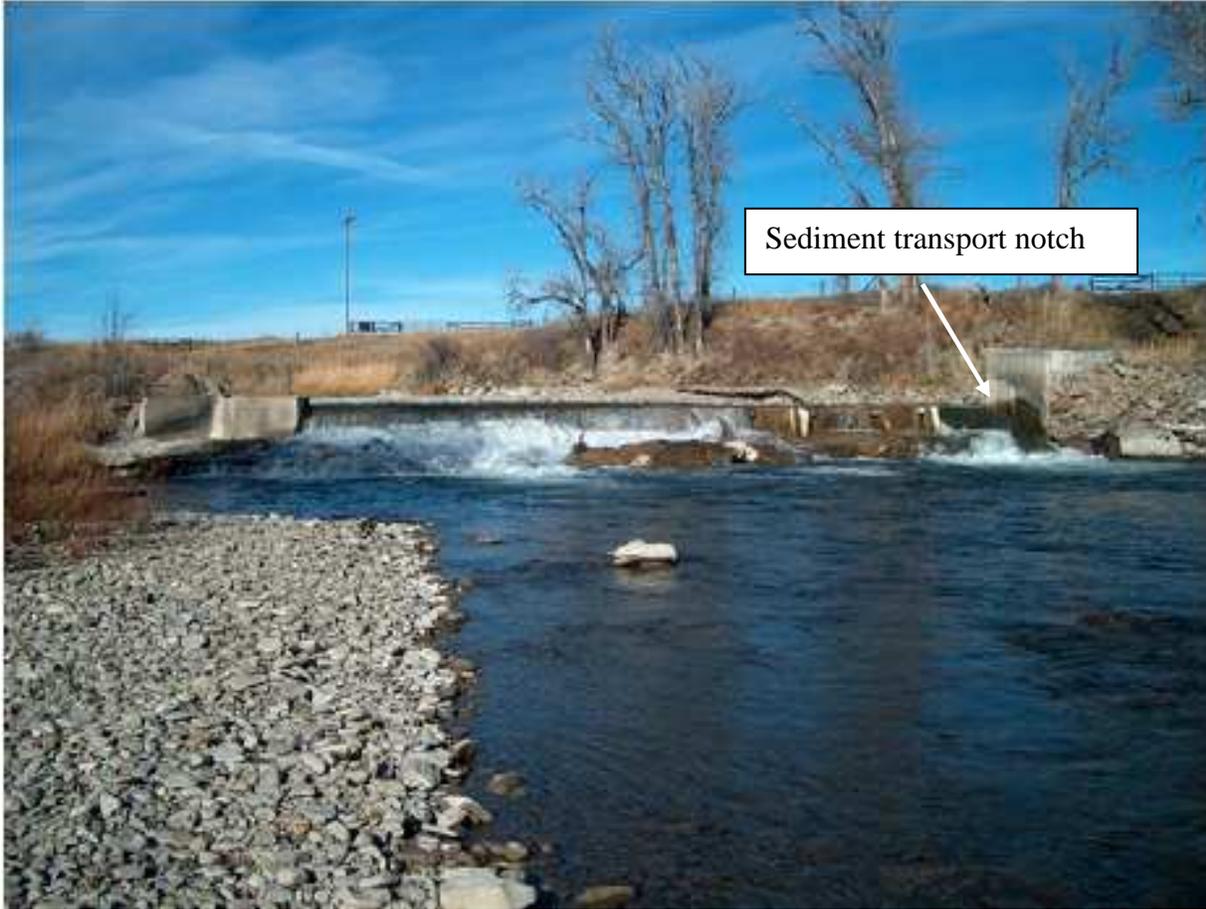
Figure 4. View of Chadbourne diversion looking upstream showing sediment passage notch.

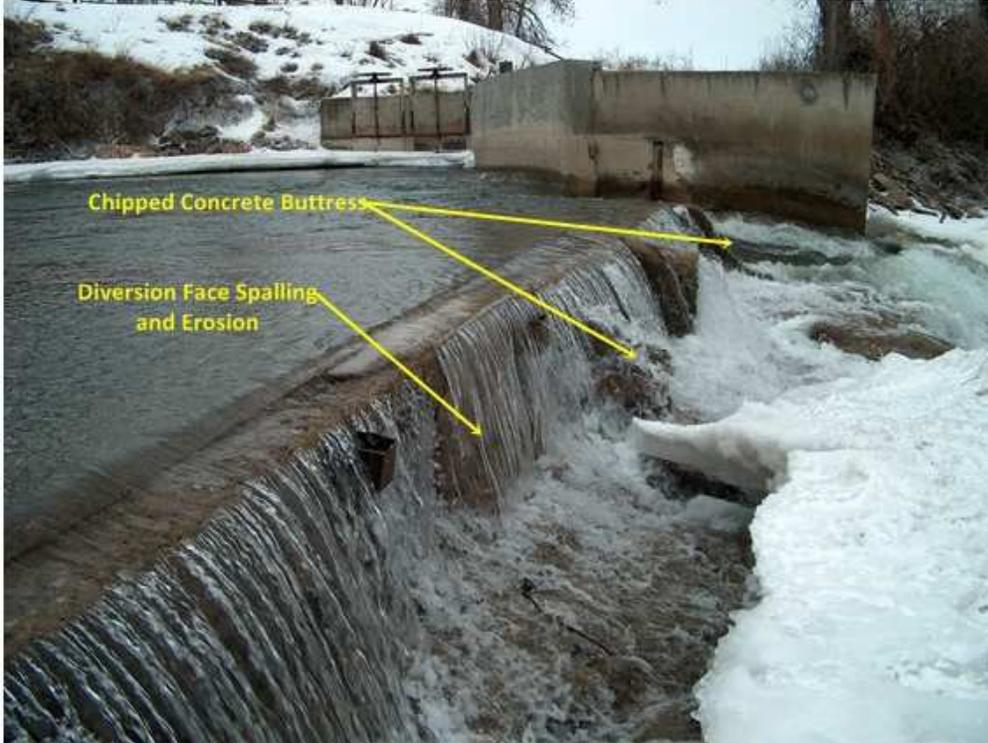
An in-depth investigation of structural stability (Allied Engineering 2011) identified specific causes of concern for the long-term stability of the structure. The migrating scour hole was among the features that could undermine the diversion. Damage to the concrete, including cracks and voids on the east and west walls, damage to three of the seven downstream buttresses, and wear and erosion on the downstream face of the dam were other considerations. The biggest problem was the erosion that had occurred along a relatively long section of the downstream face of the dam (Figure 5). This wear had claimed between 3 and 6 inches of the wall. This wall is now a relatively thin element, and as it is constantly subjected to water pressure, it is the most susceptible component of the structure. Flooding in 2011 proved the vulnerability of the face of the dam, as a 10-foot chunk fell off and required emergency repair (Figure 6). Other recommendations include repairing or replacing the three damaged, downstream abutments.

Figure 5. Front wall of the Chadbourne diversion showing erosion and spalling (Allied Engineering 2011).

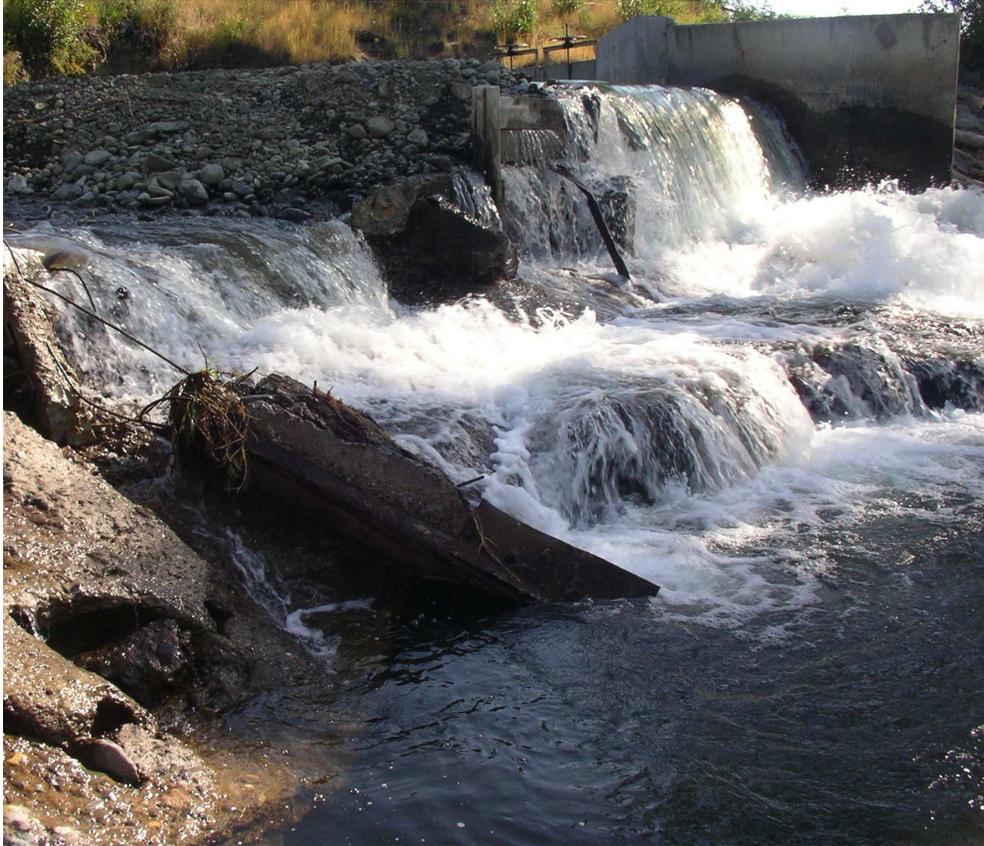
Figure 6. Broken front wall of the Chadbourne diversion and cobble berm placed to check water.
