Western Native Trout Initiative

Mabel Creek (Youngs River, Oregon) resident coastal cutthroat trout passage and habitat restoration

Project Completion Report, 2-10-2014

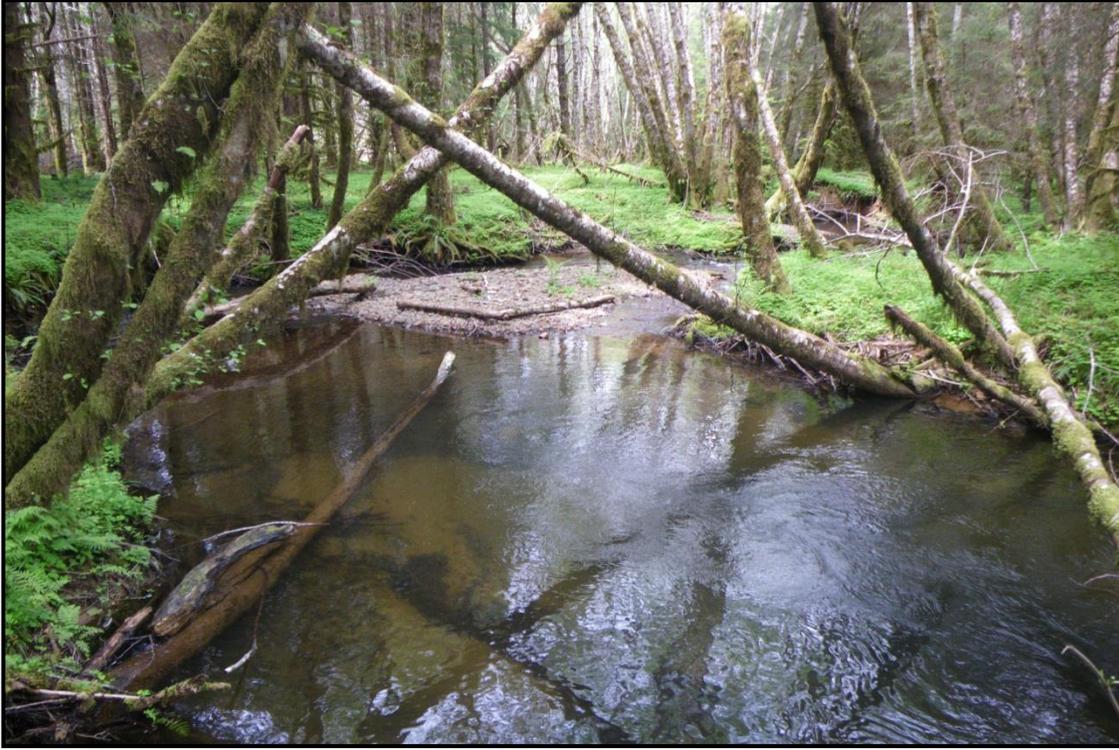
Pre Project: Mabel Creek Site Photos: Mabel Creek is a fairly low gradient stream that has some habitat features of value (undercut banks, pools) but was impacted by a floodplain road and was deficient in large wood.

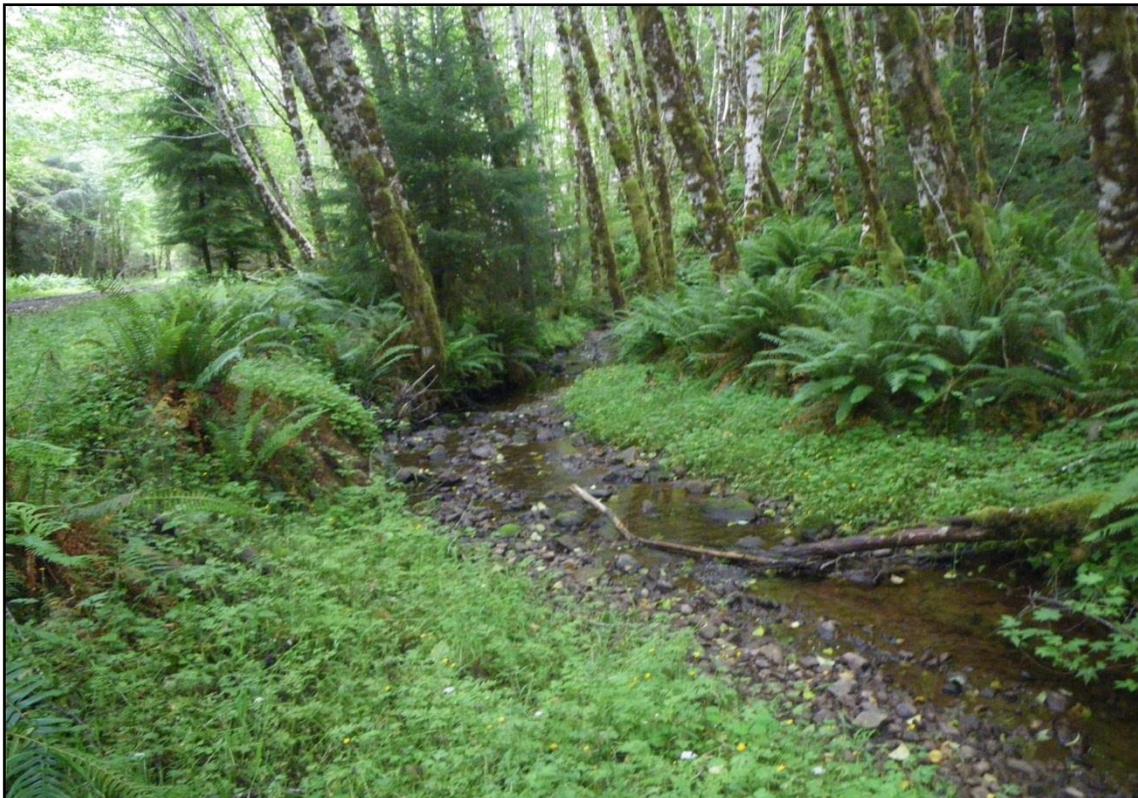
Pre Project: Mabel Creek Site Photos: Road impingement (shown by arrow) on Mabel Creek was a source of fine sediment in the Youngs River and also impacted floodplain to stream connectivity and high flow refugia habitat.

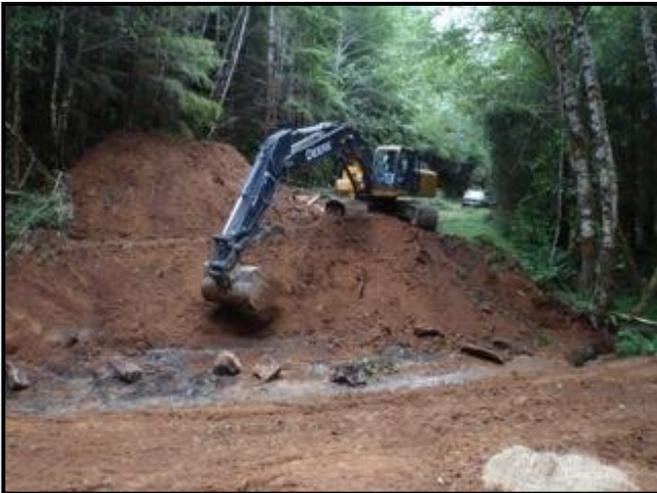
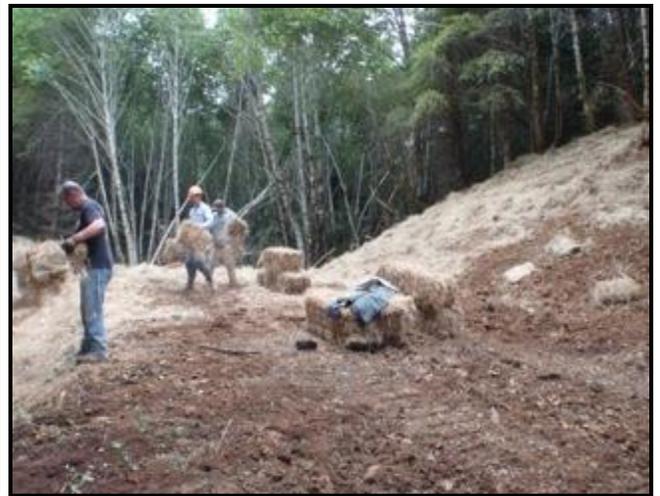
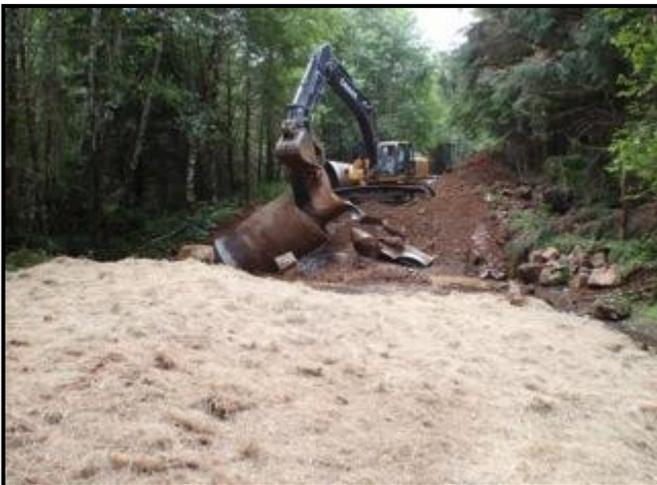
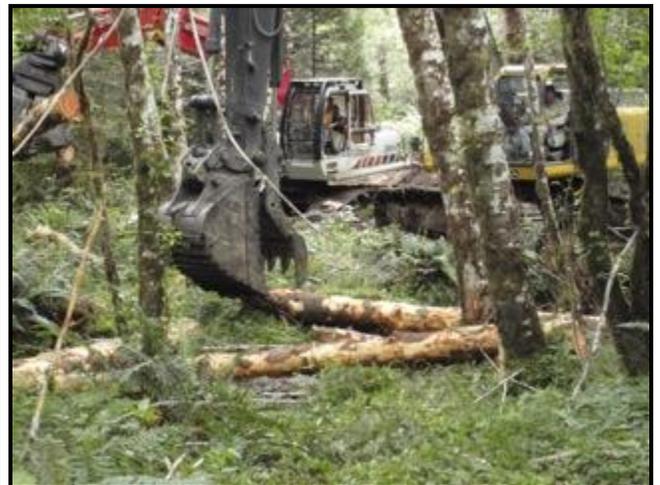
Mabel Creek Implementation Photos: *Photo 1 top left:* A total of 4 stream crossings were opened up via road decommission. The channel was opened to the full bankfull width and instream flow dispersal boulders and large wood were placed. *Photo 2, top right,* The road was removed to floodplain grade, fill was end hauled away when in areas where fill had clearly been imported or, as shown in photo 2, blended back in with the hill slope in areas where fill had been taken locally. In all cases, the bare ground was seeded with native and sterile cover seeds and mulched to protect against erosion. Additional woody plantings will occur in winter 2012-2013. *Photo 3, bottom left:* Culverts were removed as a part of road crossing decommission to open upstream passage. *Photo 4, bottom right:* Large wood was placed instream and, in a few cases, in the floodplain to provide habitat complexity, pool scouring, overhead cover, and floodplain connectivity.

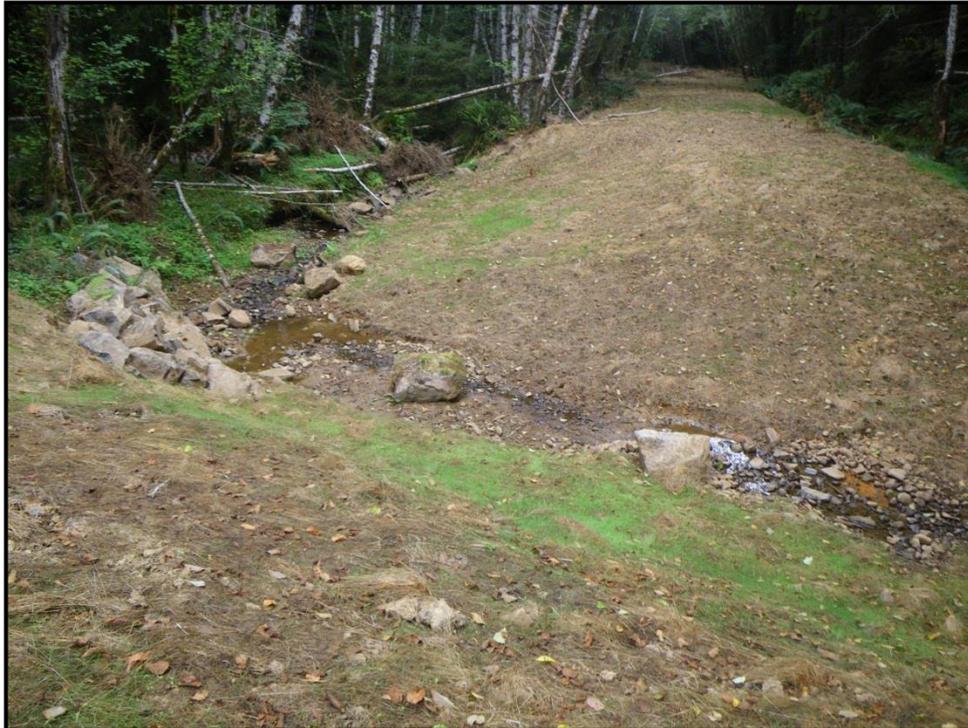
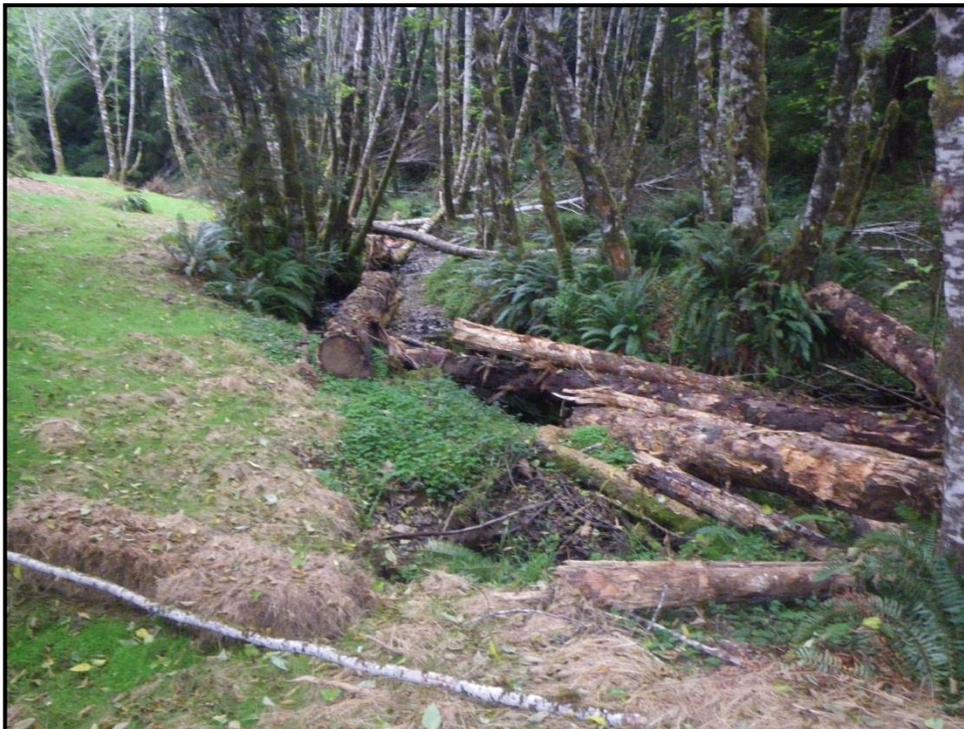
Mabel Creek Post Implementation Photos: *Photo 1 top* Road decommission at stream crossing - the channel was opened to the full bankfull width and instream flow dispersal boulders and large wood were placed. Channel at lowest seasonal flow. *Photo 2, bottom*, Large wood was placed instream and, in a few cases, in the floodplain to provide habitat complexity, pool scouring, overhead cover, and floodplain connectivity. Seeding and mulching measures to hold soil and prevent turbidity were successful.
