Bear Creek Habitat Improvement Project
Final Report
October 25, 2010

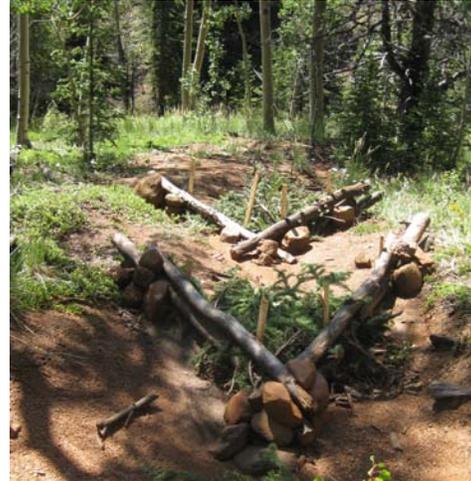
Img. 1: Brush check dams

Above the re-route, brush and rock check dams were constructed in existing drainage channels to attenuate storm flow. As rock was scarce and deadfall was abundant in the area, brush dams were constructed more often than rock (Img. 1) The construction of the brush dams is very

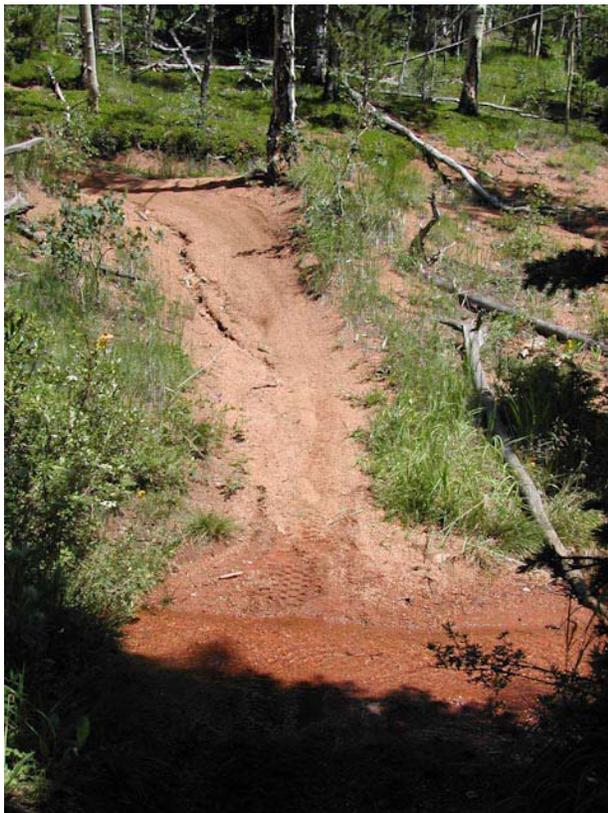
Img. 2: BEFORE closure of west end of old trail.

Special attention was paid to both closed entrances to the restored old trail. Timber deadfall and vegetation provided visual blocks, obstructing the line of sight. The west-end closure required technical construction as the old trail was steep, full of loose sediment, and crossed the stream. A series of timber risers were constructed in the old trail to catch sediment before entering the stream. Terraced rock retaining walls were built beside the trail in a steep, loose, heavily denuded area. Both areas were then seeded, re-vegetated with transplants, and matted (Img. 2 and 3).

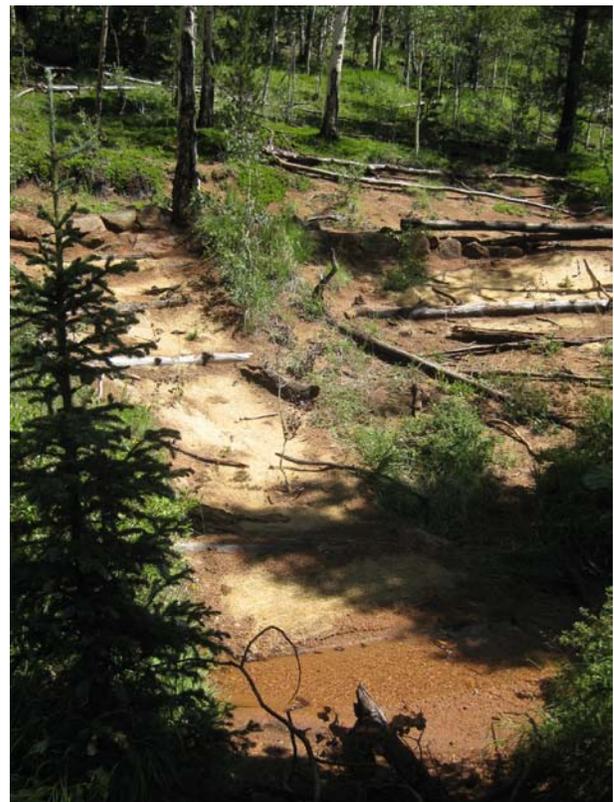
Img. 3: AFTER closure

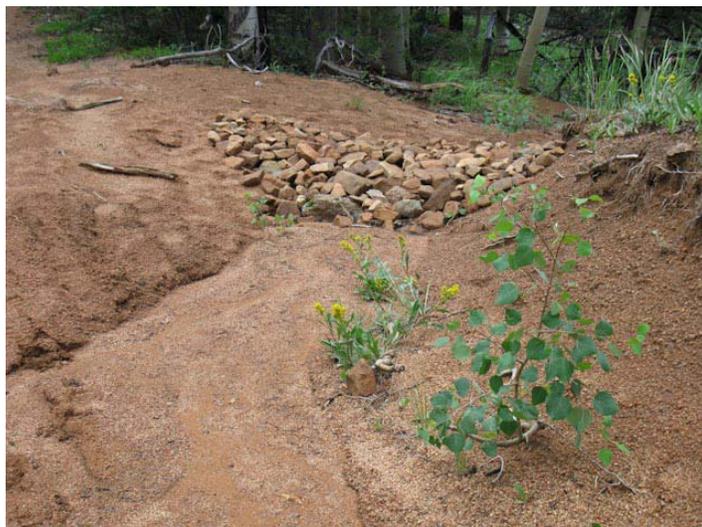
Img. 4: Rock check dam, catching sediment.

The focus of this area was mitigating the flow of sediment into the creek. Zone B already had a number of drainage channels, however, these channels fed directly into the creek, thus providing a direct corridor for sediment from the trail to Bear Creek. Rock and brush check dams were constructed in these drainage channels to catch sediment (Img. 4). Additionally, key drainage channels were redirected away from the creek to areas suitable to catch large quantities of sediment.

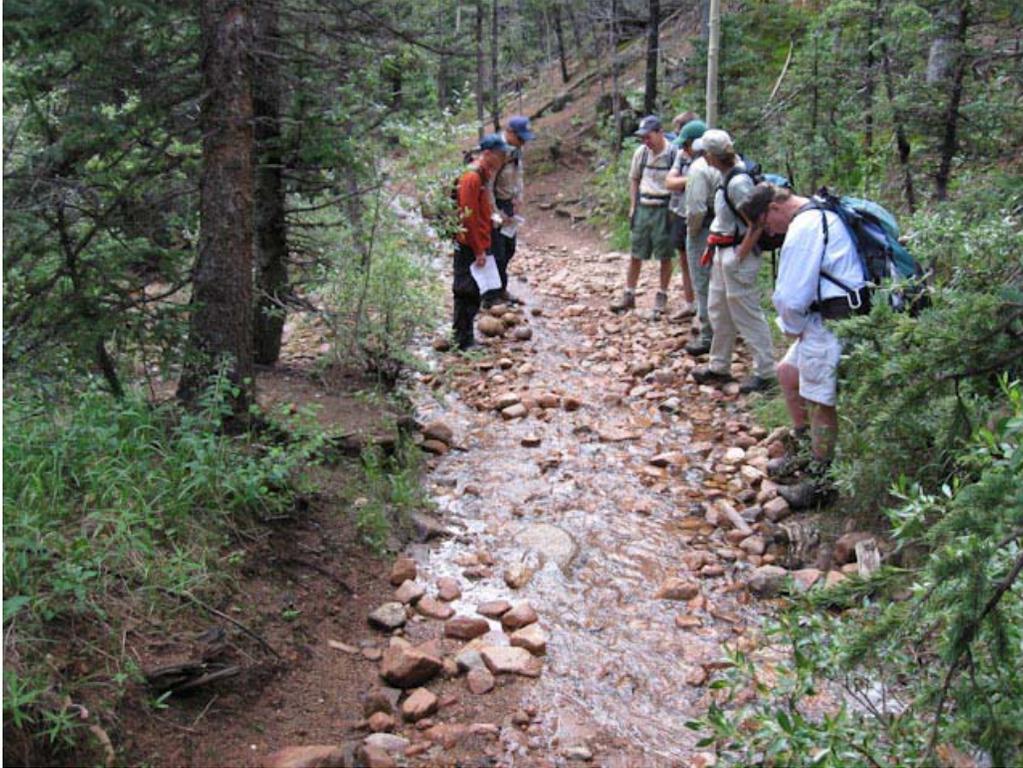
Img. 5: BEFORE water bar. Water is running down the trail.

At the site of the tributary crossing, the down-trail bank was reconstructed to keep water off the trail and in the stream corridor (Img. 5 and 6). This site had historically been a problem area with the tributary running down the trail during major and minor storm events. The original project plan for this crossing was to install a rock culvert. However, after seeing the site several times this summer it became apparent that a bridge was necessary to ensure water quality protection of the creek in this area. This was mostly due to very high flows witnessed in this tributary over the course of this summer's monsoon. Rough calculations showed comparable flow rates between the tributary and Bear Creek. Due to the similar flow rates it was felt that this volume of water *could not* be adequately contained within an appropriately sized rock culvert. Prior to construction of the bridge, RMFI rebuilt the stream bank, raising the bank 3 feet to where it historically stood. This reconstructed bank not only redefines the stream channel, but also serves to keep sediment from the trail from entering the stream.

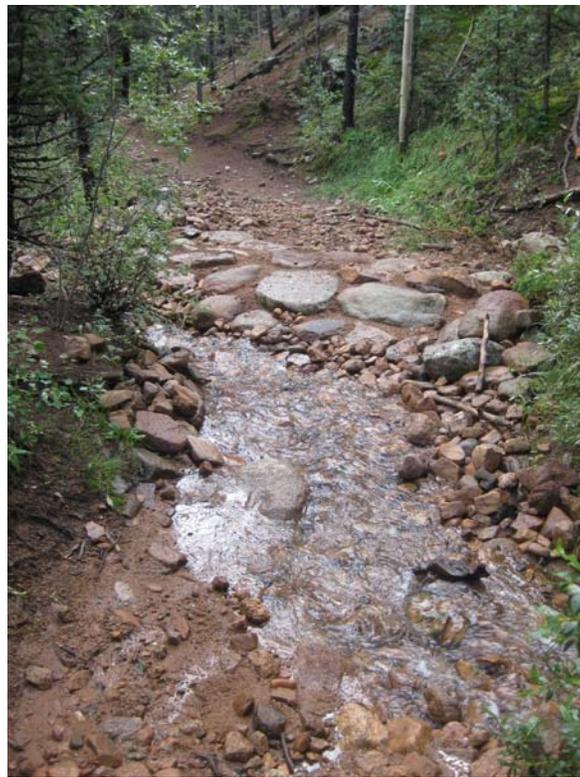
Img. 6: AFTER water bar and before new bridge.

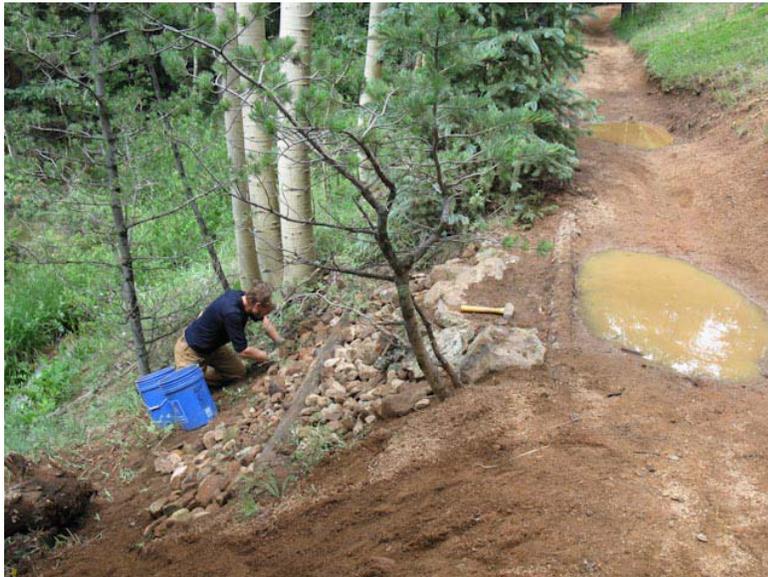
Img. 7: Outslope stabilization with timber logs and rock retaining wall.

The work on Trail 667 focused on stabilizing the outslope of the trail by constructing rock and timber retaining walls. 108 feet of timber outslope stabilization and 50 square feet of multilevel rock retaining wall were constructed (Img. 7). The majority of work in this zone focused on Trail 720-A. 720-A steeply intersects Trail 667 from the southwest. Just before this intersection, there is a bridge-covered stream crossing. To minimize sediment deposition into the stream, two water bars were constructed above the bridge crossing. Further up Trail 720-A, a major tributary crosses the trail. A large, cobbled drain was constructed to re-direct water back to the original channel (Img. 8 and 9). This drain keeps the water clear and sediment-free. In the same area, 39 feet of timber logs were placed on the outslope of the trail to provide slope stabilization and prevent sediment from running off the trail into the stream.

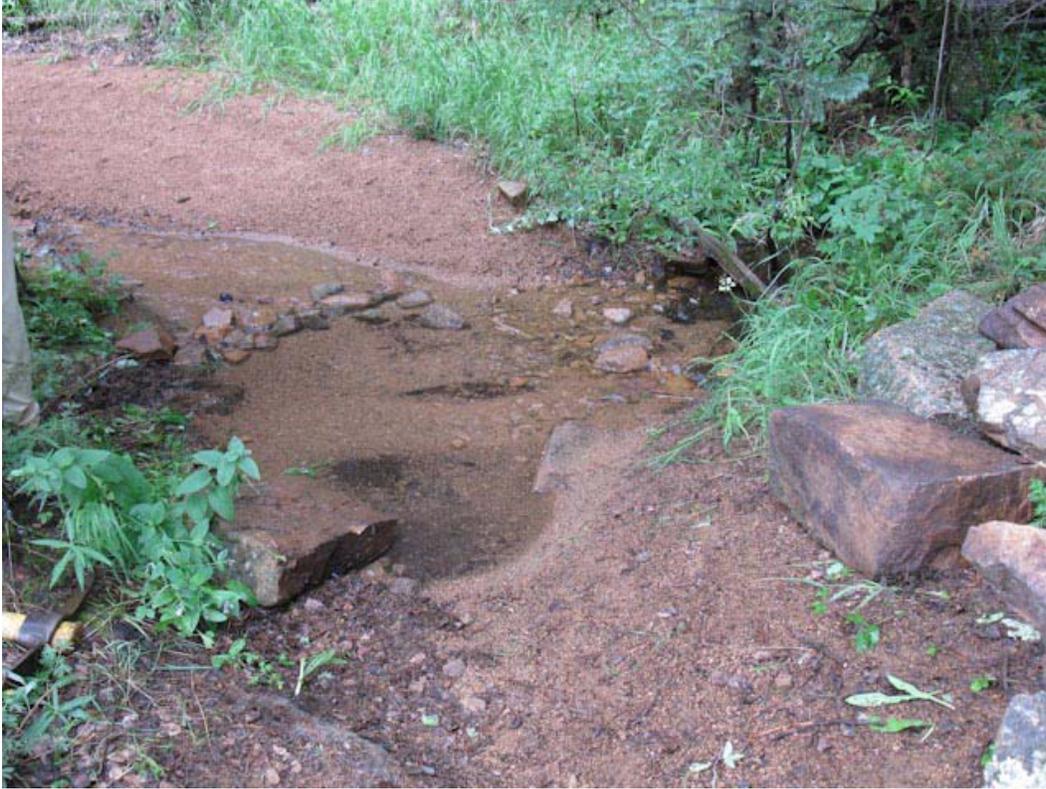
Img. 8: BEFORE drain. Water channel is unnecessarily wide.

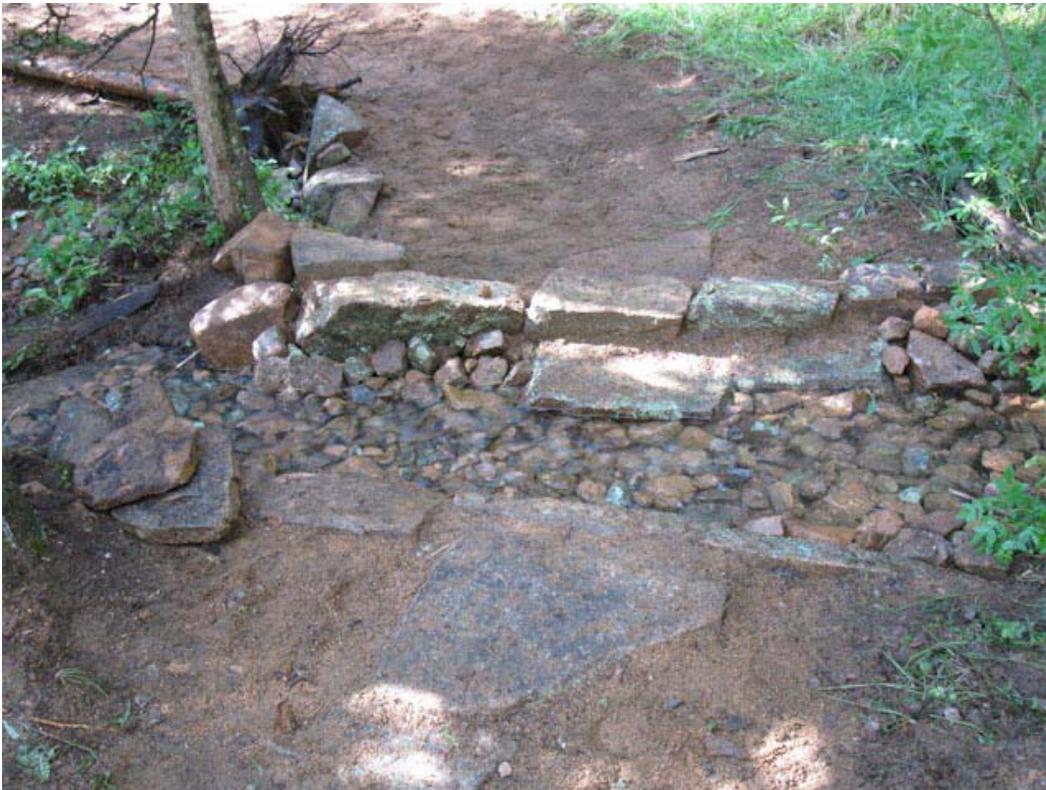
Img. 9: AFTER drain. Stream channel is constricted, water is kept free of sediment with cobbles.

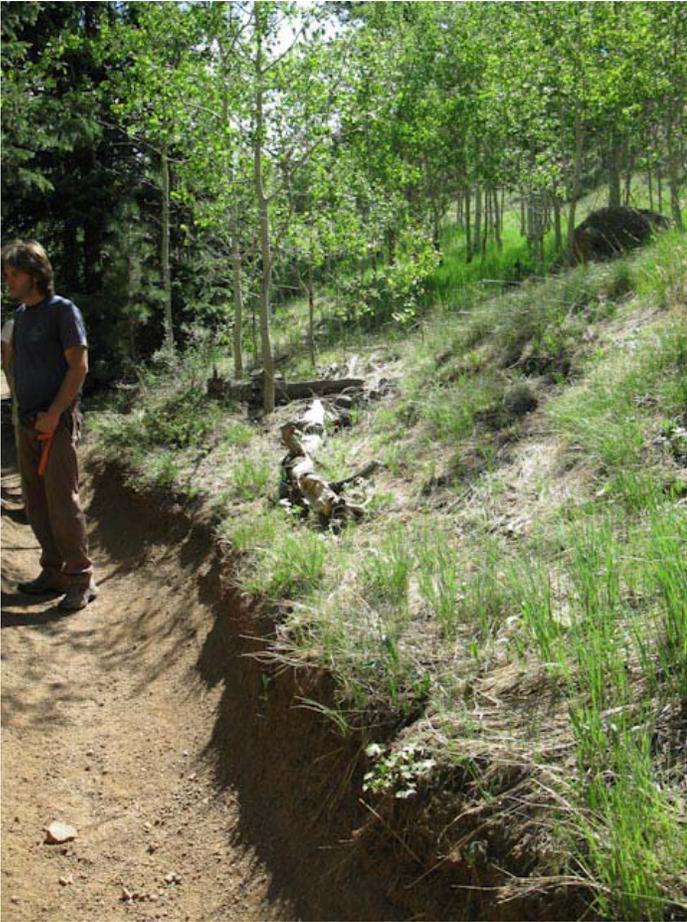
Img. 10: Above left: BEFORE. New trail cuts to right.

The trail was re-routed in this zone to move it farther from the stream (Img. 10, 11 and 12). The old trail came within a few feet of the stream bank. The crew cut in 335 feet of new trail approximately 30 feet from the stream. The old trail was restored with 193 bunch grass transplants taken during construction of the new trail. A total of 1,745 square feet of old trail was restored with transplants, seed, and erosion control matting. The new trail required only a few drainage structures and outslope reinforcement.

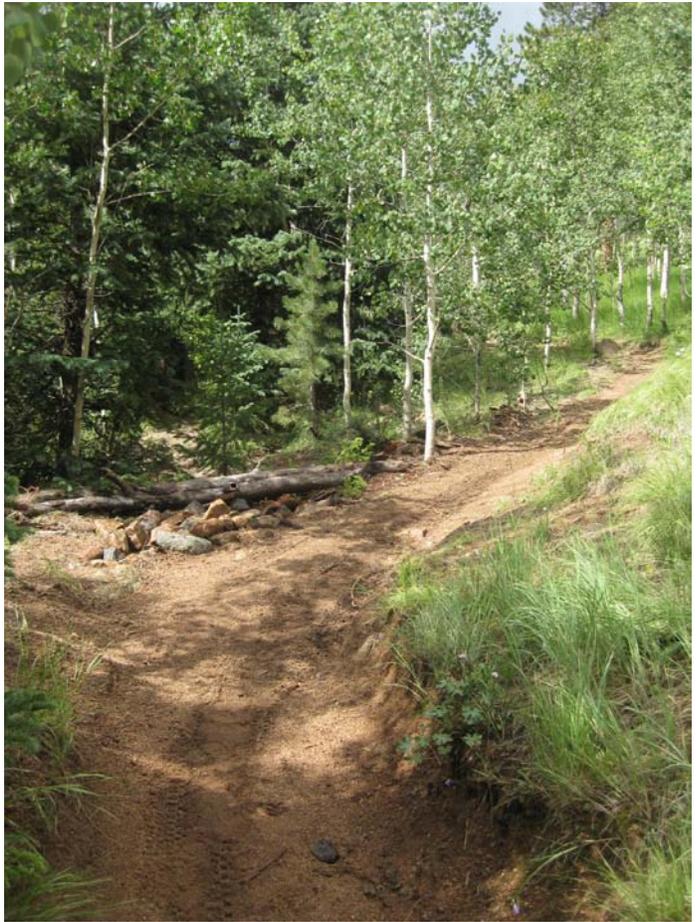
Img. 11: Above right: AFTER. Old trail closed to left, new trail cut to right.

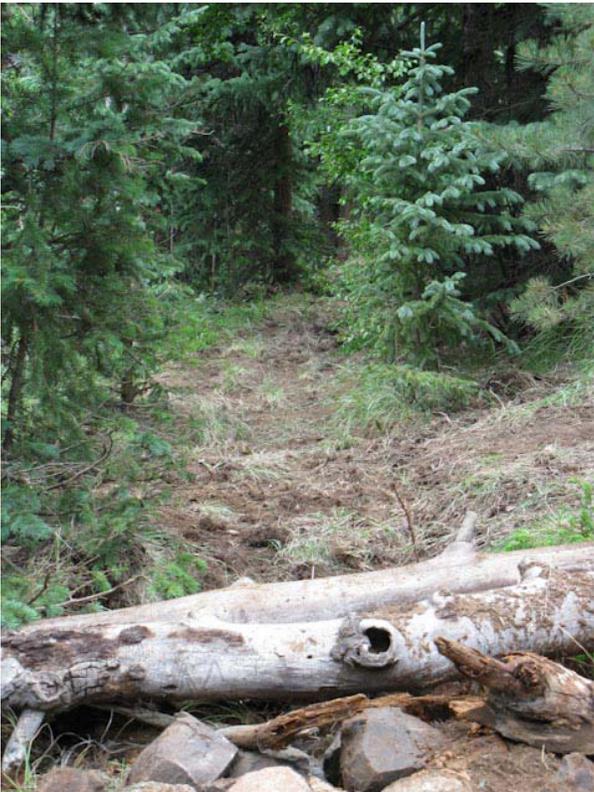
Img. 12: Left: Old trail restored with soil decompaction, transplants, and visual deterrents.

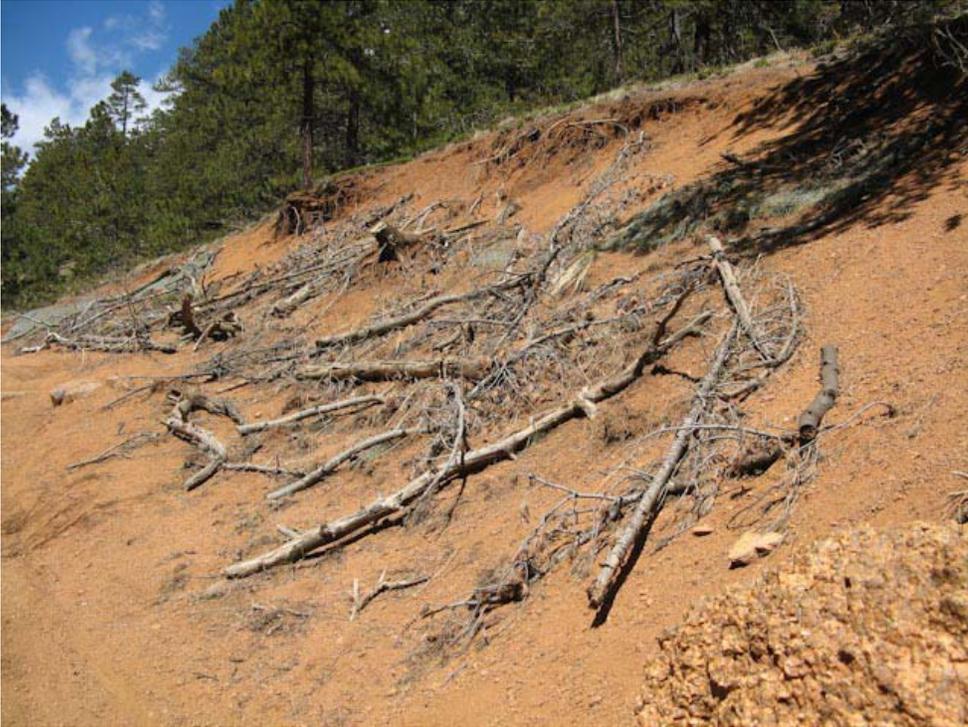
Img. 13: BEFORE

On a steep, eroded slope above the trail, 1,809 square feet of area was restored with seed and erosion control matting (Img. 13 and 14). Old, sediment-covered erosion control matting illustrates that this spot was historically a problem area for restoration. To ensure successful results, the crew placed the matting above the denuded area, staking the edge in vegetation.

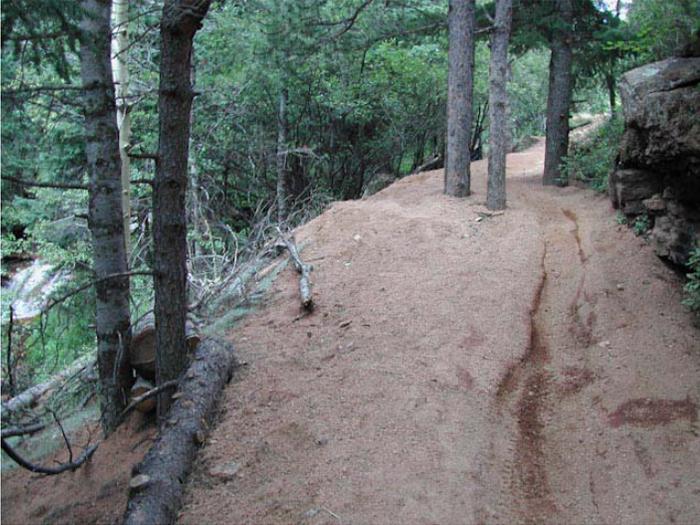
Img. 15: BEFORE. Trail is unnecessarily wide and outslope is unstable.

Lastly, this zone required the construction of one major outslope rock retaining wall in a heavily damaged, steep area that was depositing a large amount of sediment into the stream. The crew moved dozens of 300+ pound rocks into the hillside, creating a stable outslope to the trail and protecting the stream from further sediment deposition. Additionally, six timber logs placed for outslope reinforcement were constructed in this zone (Img. 15-18).

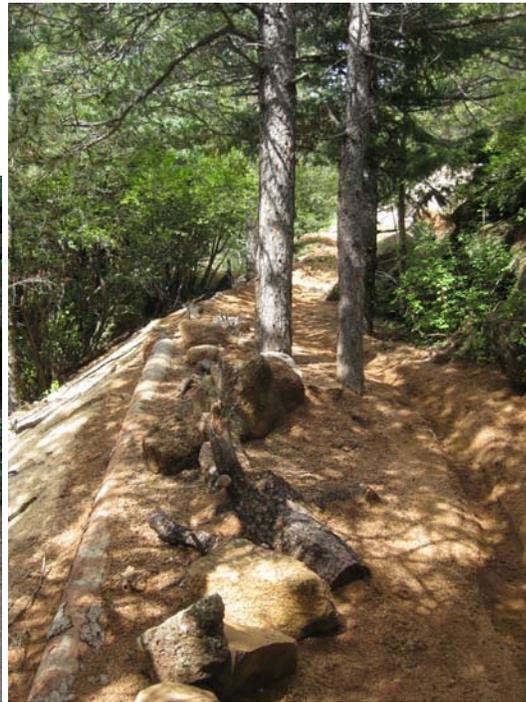
Img. 16: AFTER. Trail is narrowed. Outslope is stabilized with timber and erosion control matting.

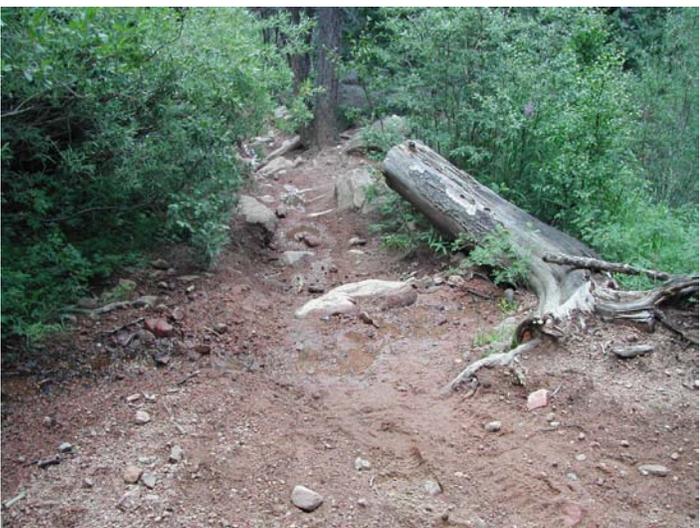
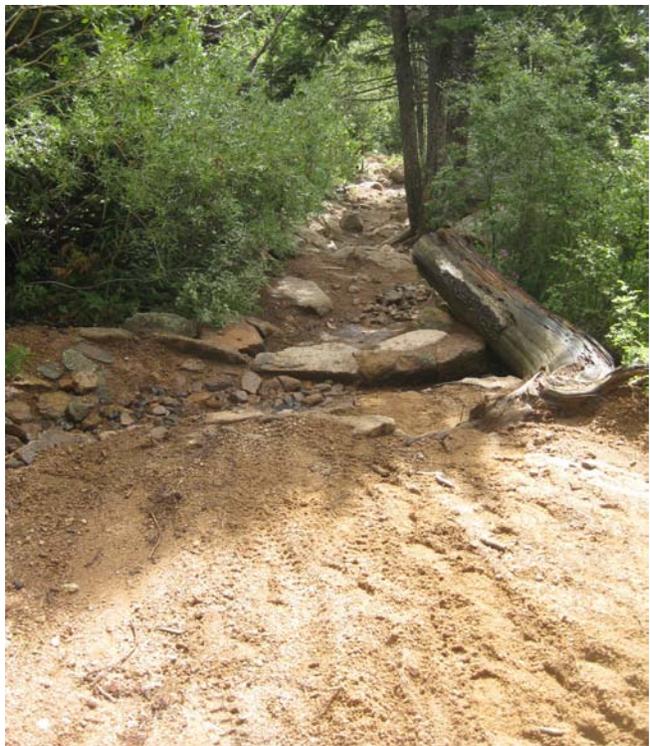
Img. 17 and 18: BEFORE and AFTER on large drain installation looking down-trail.

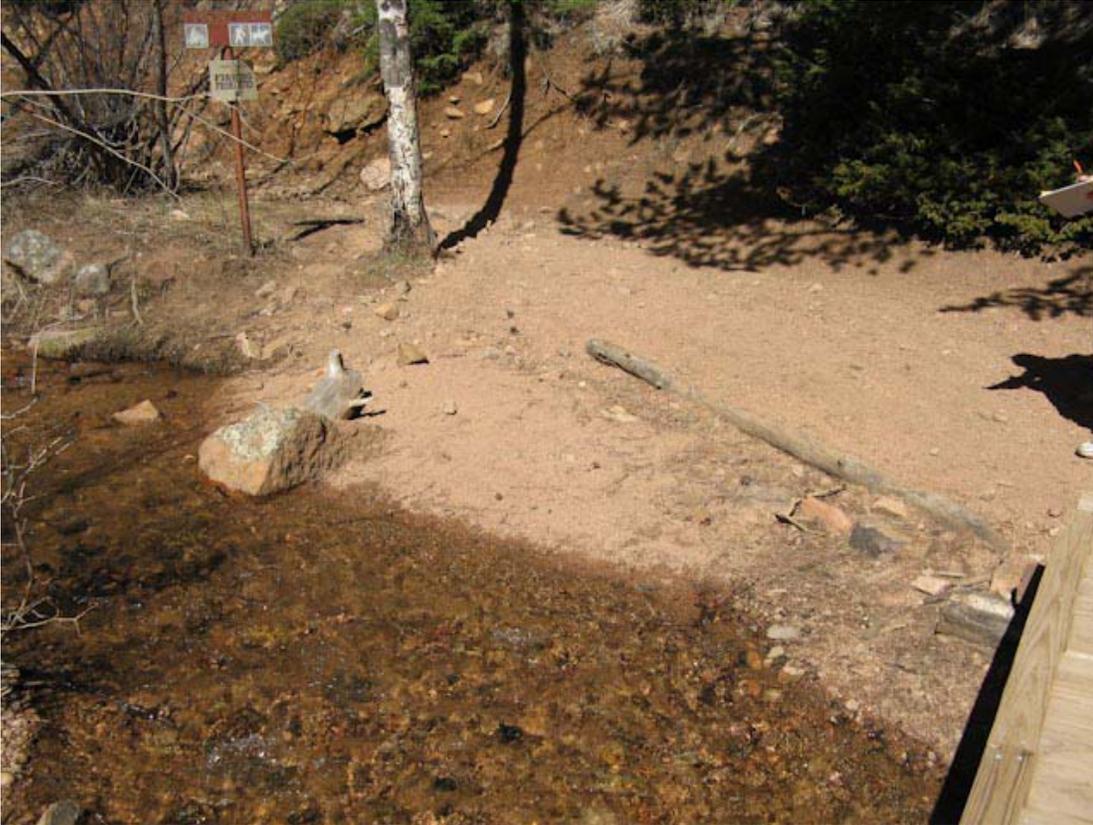
Img. 19: BEFORE bank reconstruction.

On the western side of the stream, the bank was reconstructed to its original height (Img. 19 and 20). The reconstruction involved constructing a rock retaining wall as the framework, and then building on both sides of the structure with logs and smaller rock. Willow was planted along the stream.

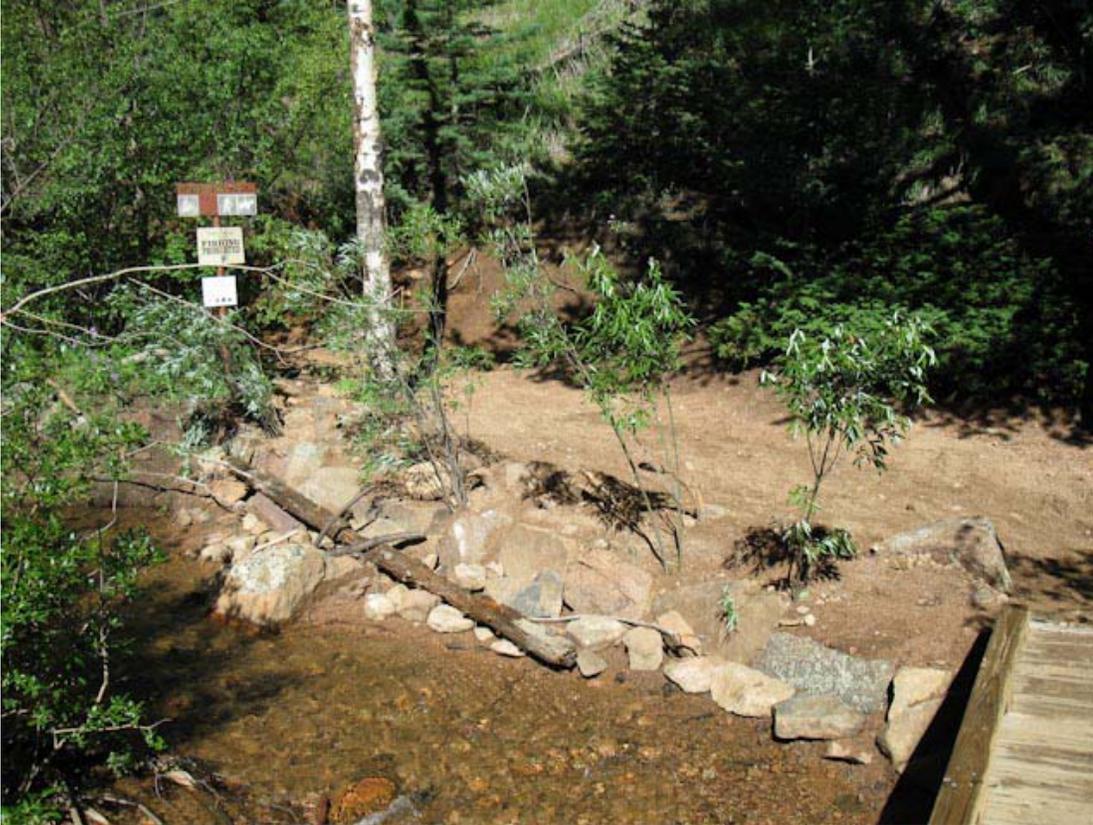
Img. 20: AFTER bank reconstruction.

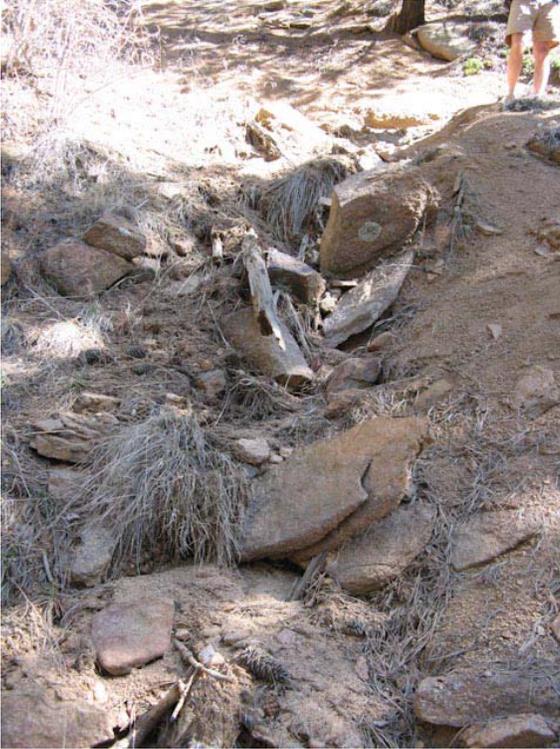
Img. 21: Left: BEFORE rock retaining wall construction. Slope is very unstable.

On a steep, eroded slope just above the stream, a large, 2-tiered rock outslope retaining wall was constructed (Img. 21, 22, and 23). This structure serves to stabilize both the trail and slope, and mitigate sediment deposition into the stream channel. Further upstream, 5 drains were placed in the trail to provide an avenue for water seeps to cross the trail (Img. 24 and 25).

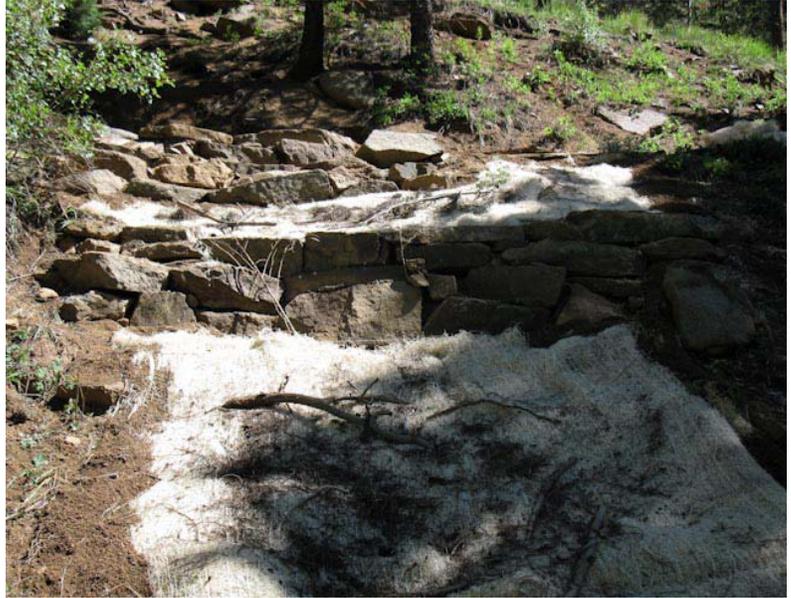
Img. 22: Right: AFTER. Rock retaining wall and restoration.

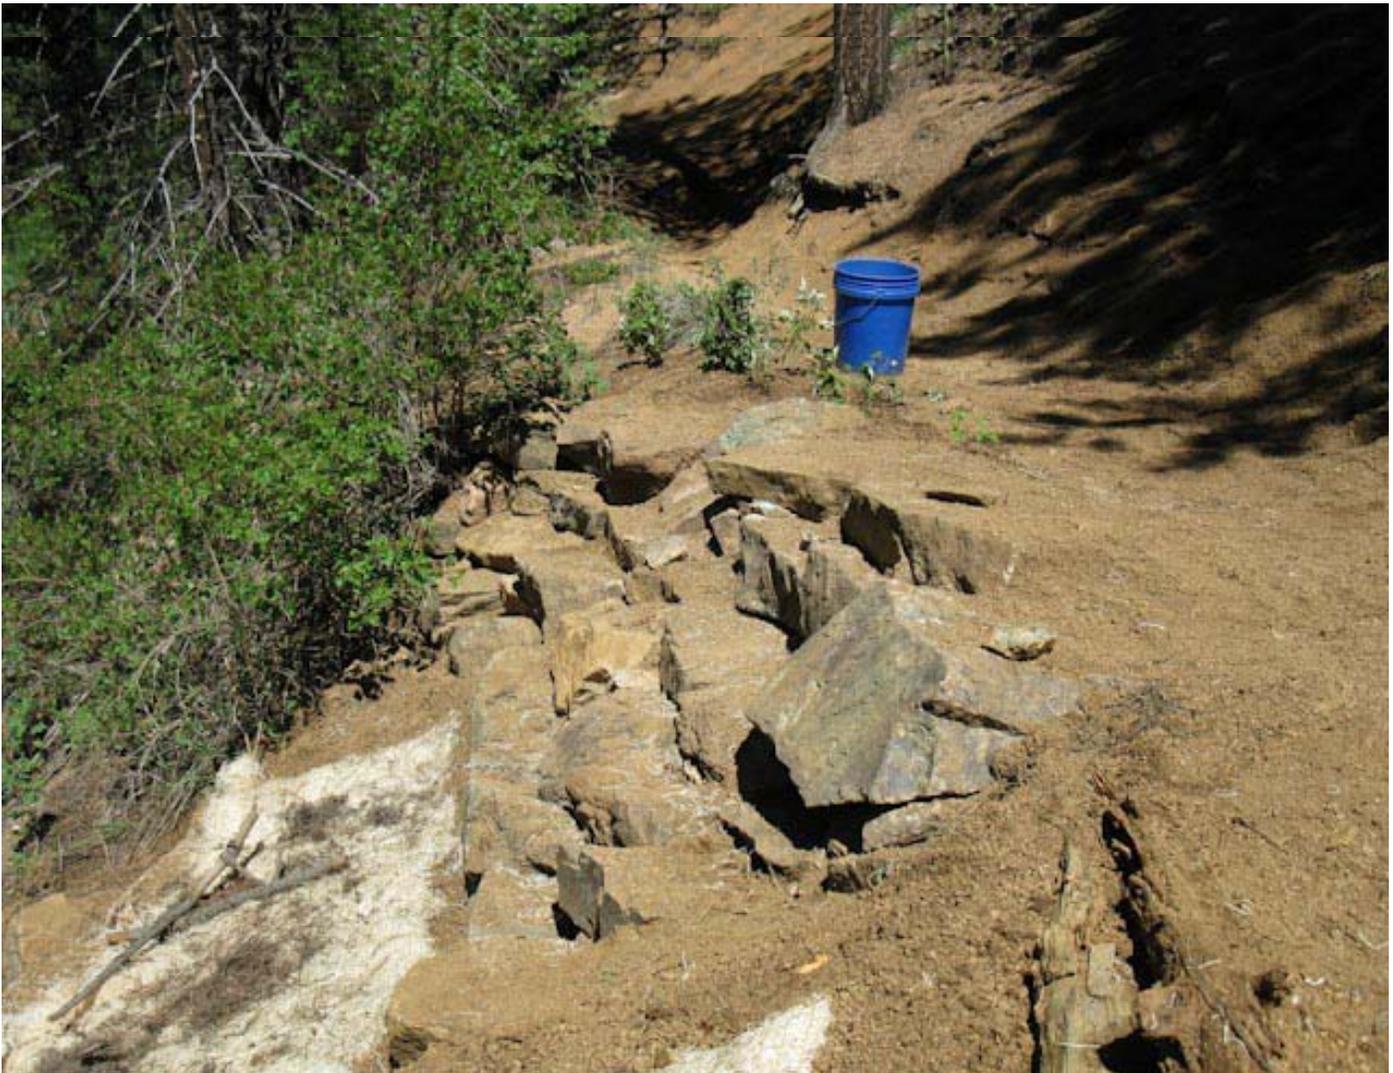
Img. 23: Below: AFTER. Rock retaining wall and restoration.

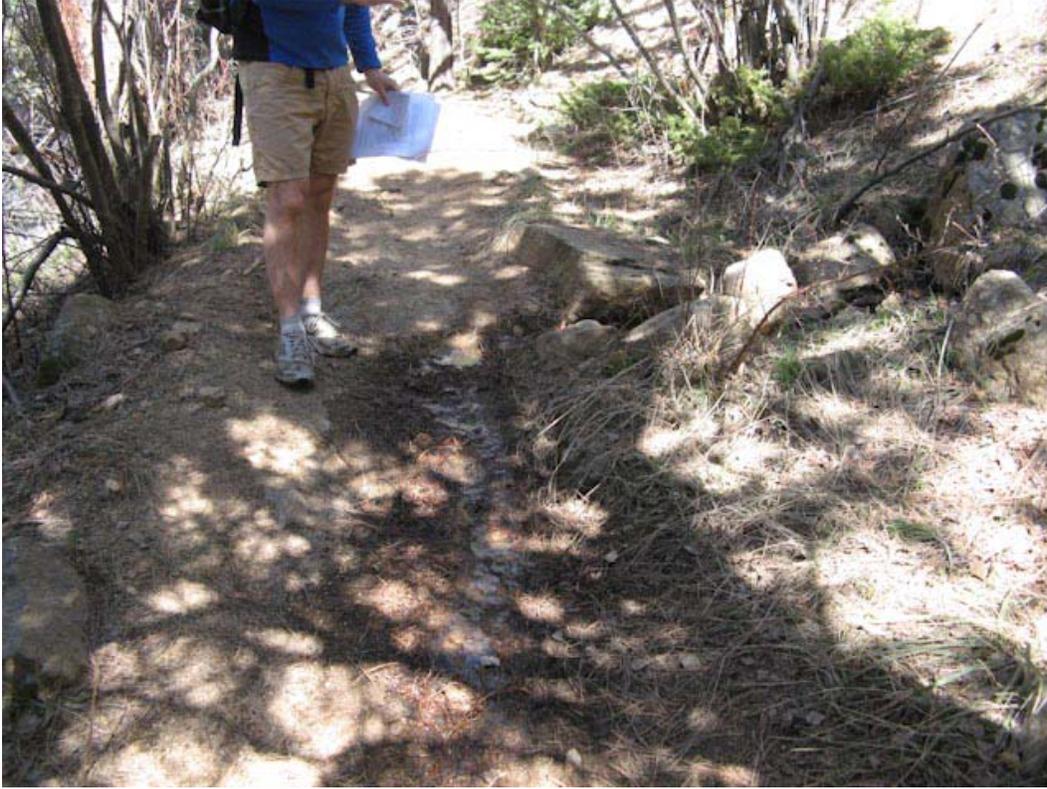
Img. 24: BEFORE. Water seep

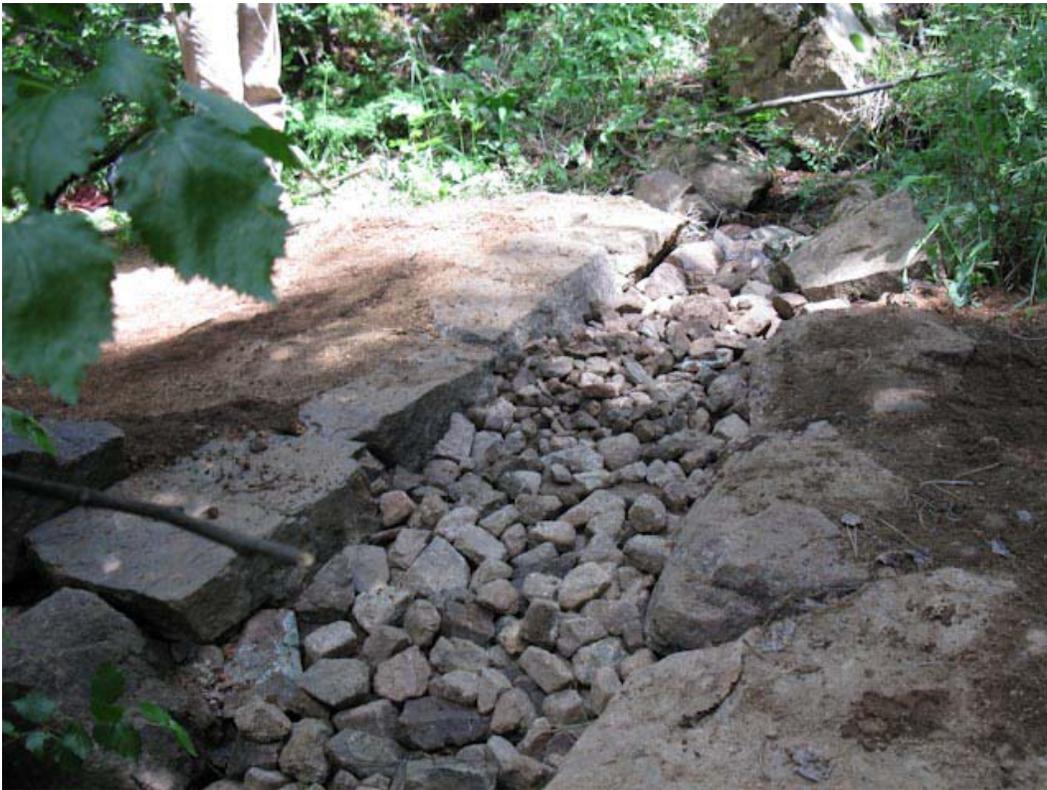
Img. 25: AFTER. Drain
