# South Fork Chalk Creek Cutthroat Trout Passage Project

By  
Paul Burnett  
Aquatic Biologist  
Utah Division of Wildlife Resources

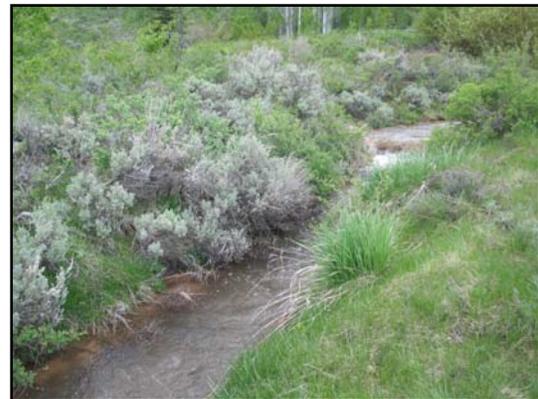
**Figure 1:** Habitat structures constructed in Segment A.

Four stream segments and three small ponds are located on the properties. Stream Segment A flows into the Oswald Pond and was used by cutthroat trout prior to project implementation, but habitat conditions were in poor condition

due to a lack of pool habitat and overhanging vegetation. Segment B is

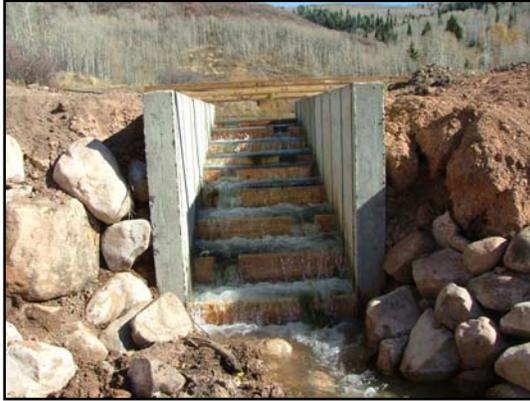
**Figure 2:** New fish ladders constructed on both ponds with wooden steps in place.

The Blonquist and Oswald Ponds presently support strong populations of Bonneville cutthroat trout that reproduce naturally and overwinter. Both pond outlets were complete barriers to fish migrations and were replaced with concrete outlet structures with fish ladders. In addition to the pond outlets, we constructed step pool complexes below each pond outlet by placing large rocks to create channel roughness. In the process, the dam of the Oswald Pond was strengthened by the addition of clay material.

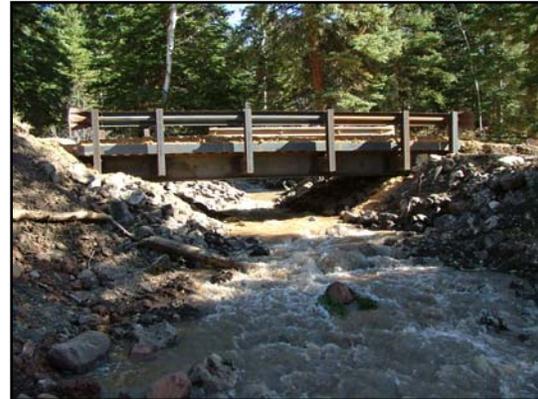
**Figure 3:** A new bridge, which has replaced a previously existing culvert that was considered a partial fish migration barrier.

The final phase of this project included the reconstruction of two road crossings on the South Fork Chalk Creek. Both road crossings were considered partial migration barriers, especially at low water levels.
